BRADY'S RUN DAM

NDI I.D. NO: PA-257

PHASE I INSPECTION REPORT
NATIONAL DAM INSPECTION PROGRAM

(11) MAY 1979

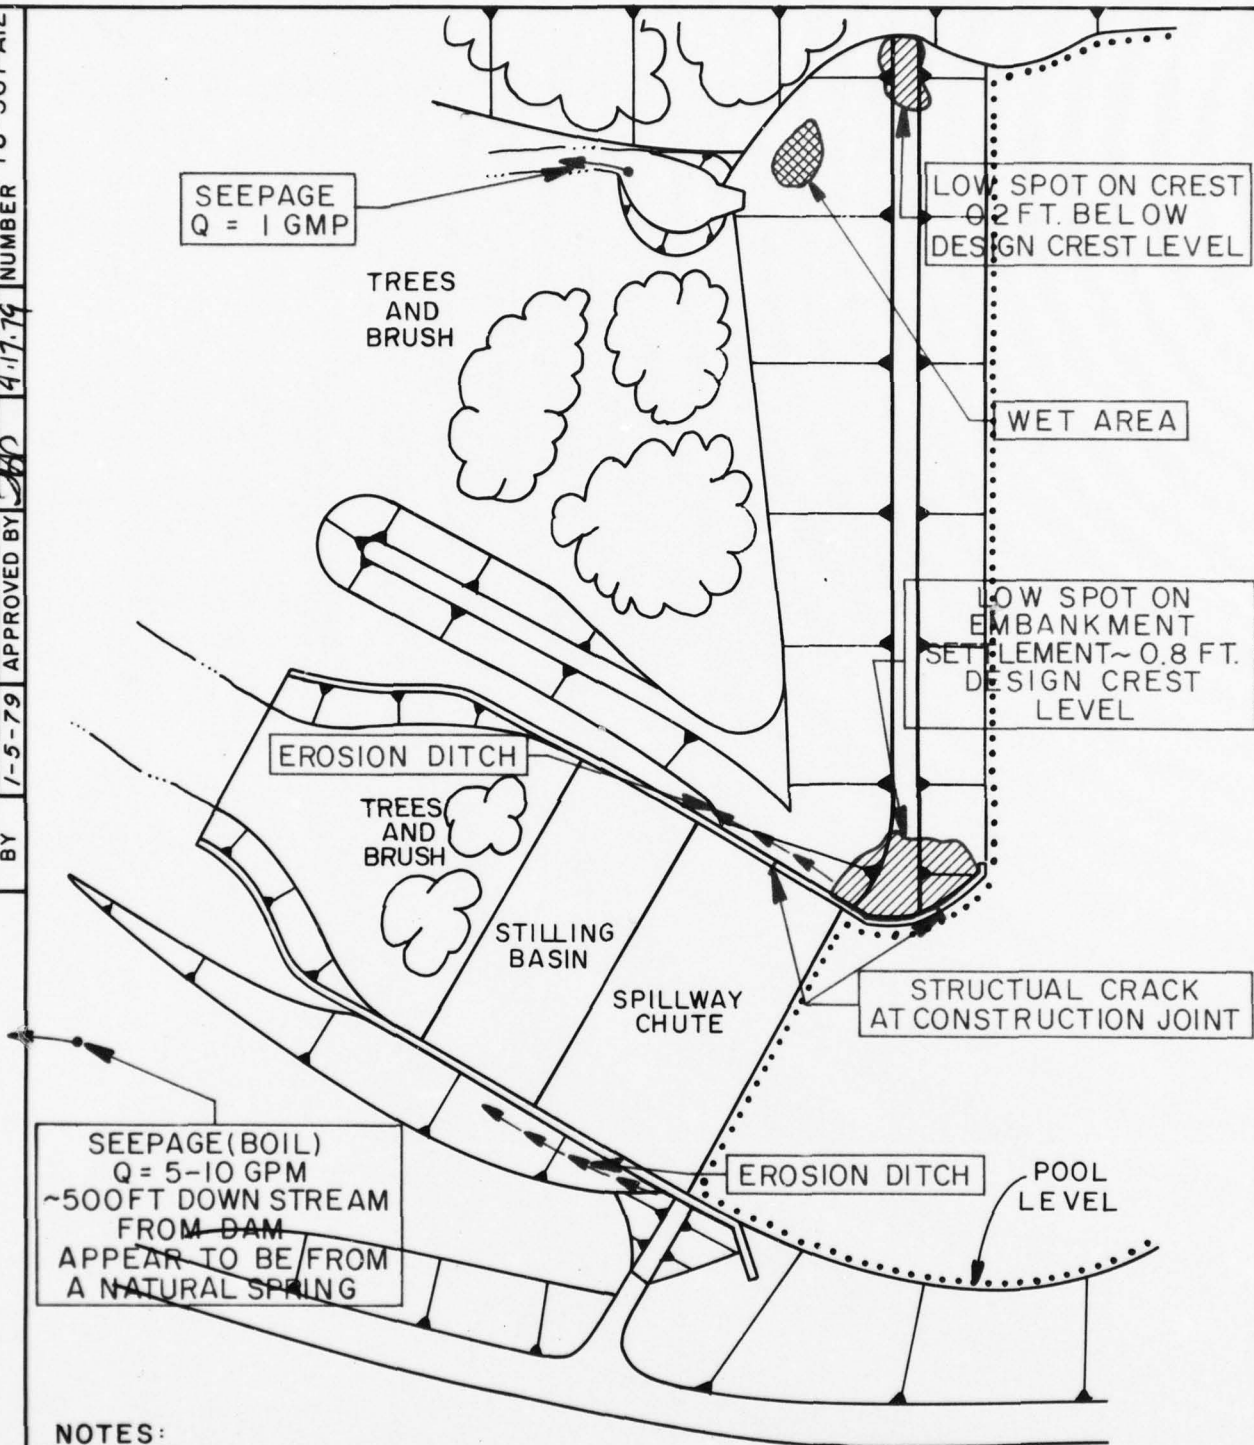
1. SPILLWAY FREEBOARD
(MEASURED FROM LOWSPOT
ON CREST) = 9.0 FEET.
2. POOL LEVEL DATE OF
INSPECTION: 0.2 FEET
ABOVE SPILLWAY CREST.
